Narrative Information Sheet

R04-19-C-003

4. Property Information: Former Elks Lodge, 504 Washington Avenue, Greenville 38701

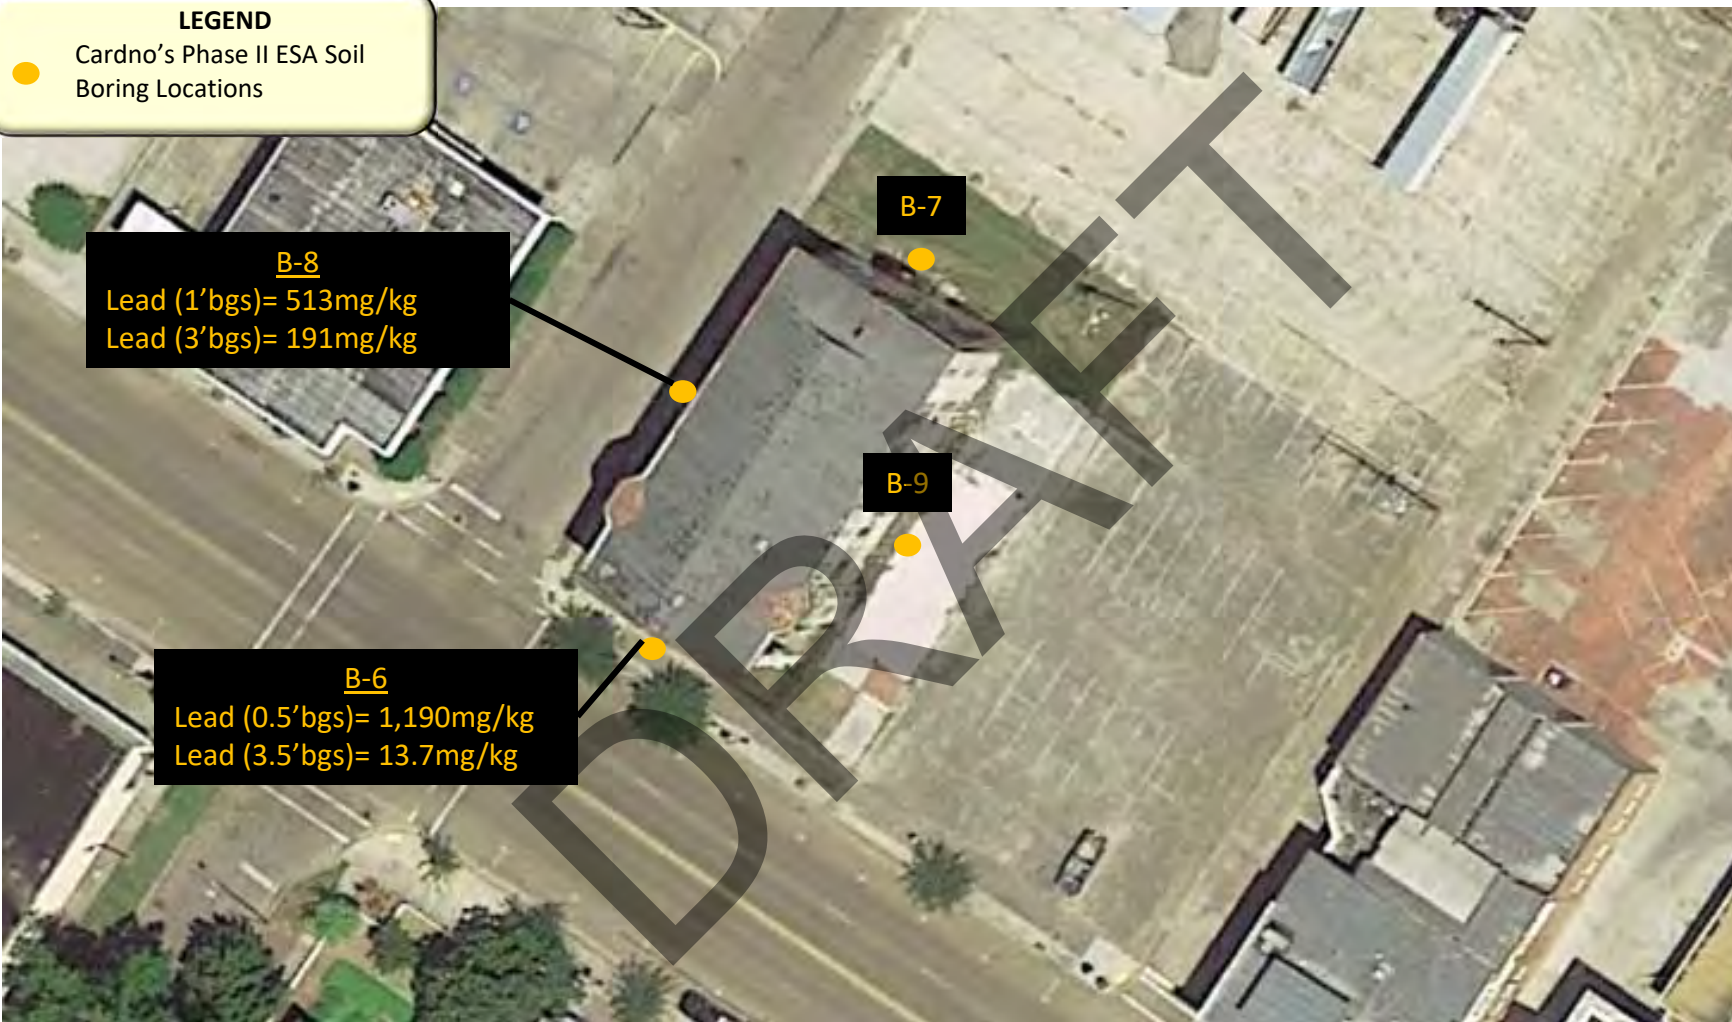
B-6

Lead (0.5'bgs)= 1,190mg/kg
Lead (3.5'bgs)= 13.7mg/kg

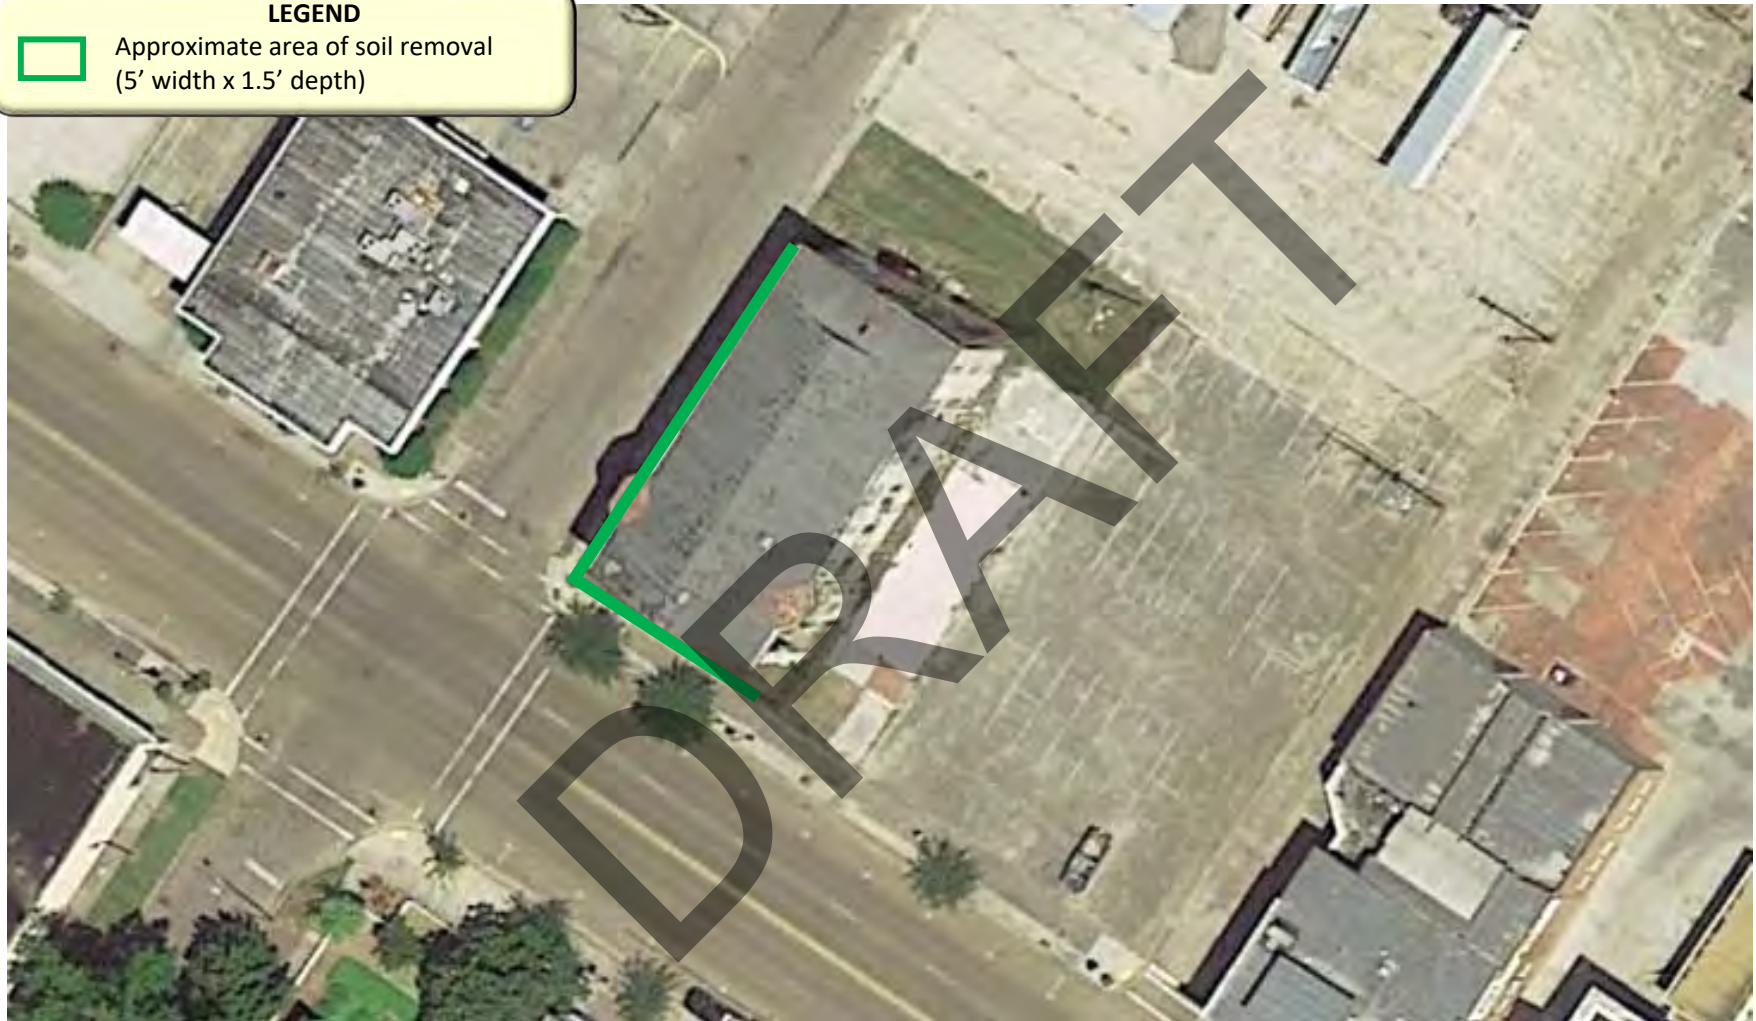
Approximate area of soil removal
(5' width x 1.5' depth)

Cardno will recommend that the identified lead contamination in the shallow soil at the Elks Lodge should be reported to MDEQ for their evaluation. Further, it is proposed that removal and proper disposal of the contaminated soil coincide with building demolition, as it is likely that the presence of lead in the soil is associated with the deteriorated lead-based paint on the exterior of the building. The report is still in progress, but tables of the Phase II ESA findings, maps with soil boring and monitoring well locations, and soil contamination locations are included as **Appendix B3**.

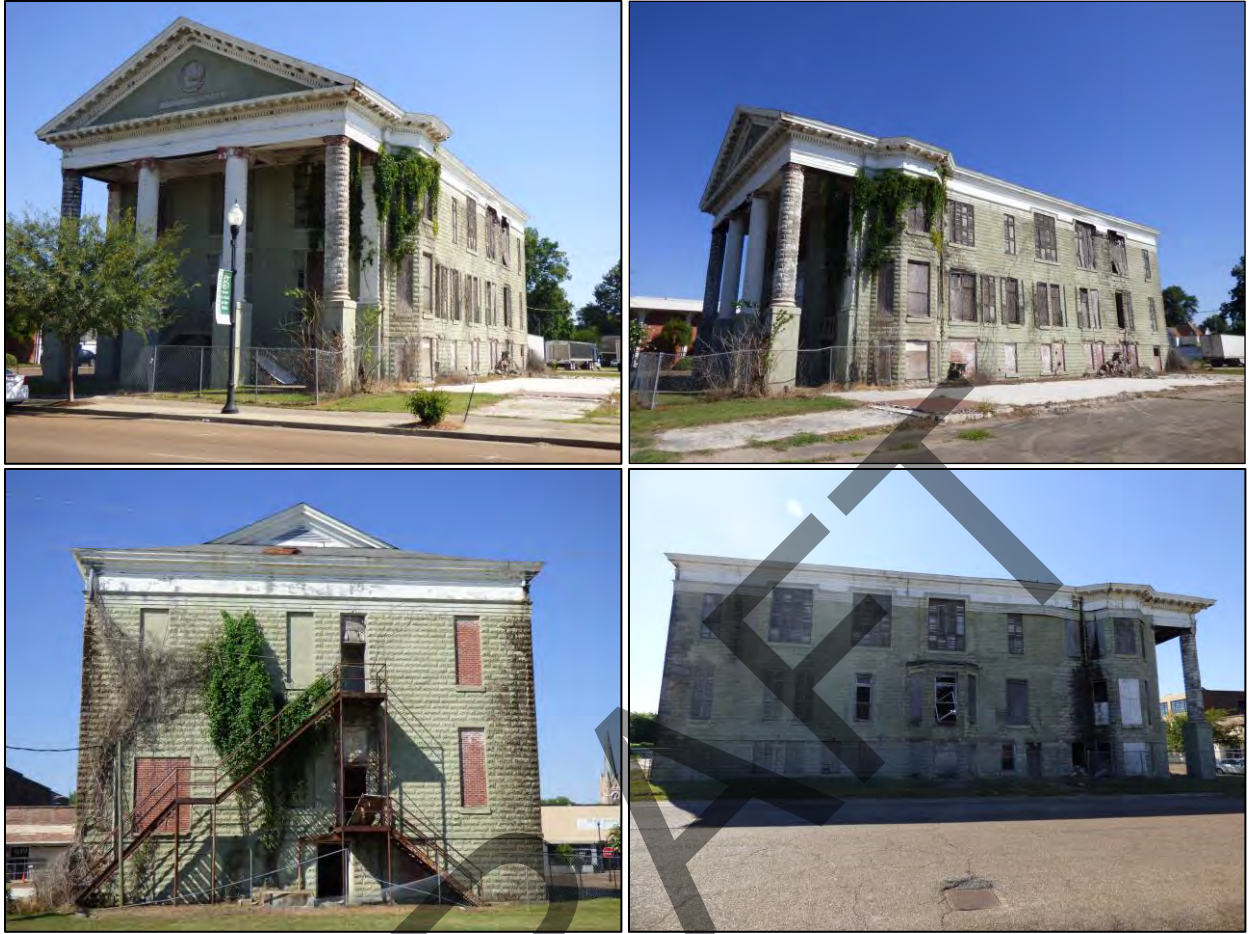
Figures 2 - 5

Figure 2: South end (front) elevation. Figure 3: East side elevation. Figure 4: North end (rear) elevation. Figure 5: West side elevation

Exterior observations found severe movement of all perimeter side walls. Moderate sized diagonal cracks accompanied by severe arch failure were present above and below most windows. Continuously reinforced bond beams had originally been installed as headers above the windows and also had been used to support the second and third floor framing. Most bond beams had either split or broken. Many had completely lost their split face block shell, exposing the concrete infill and its reinforcing bars. Severe degradation to the rebar and concrete infill was common. The upper wall sections (near the roof framing level) converted to a multi-wythe brick wall system. This upper brick section had partially collapsed in many locations with bricks falling out and laterally displacing the original frieze trim. This was accompanied by visible roof surface irregularities.

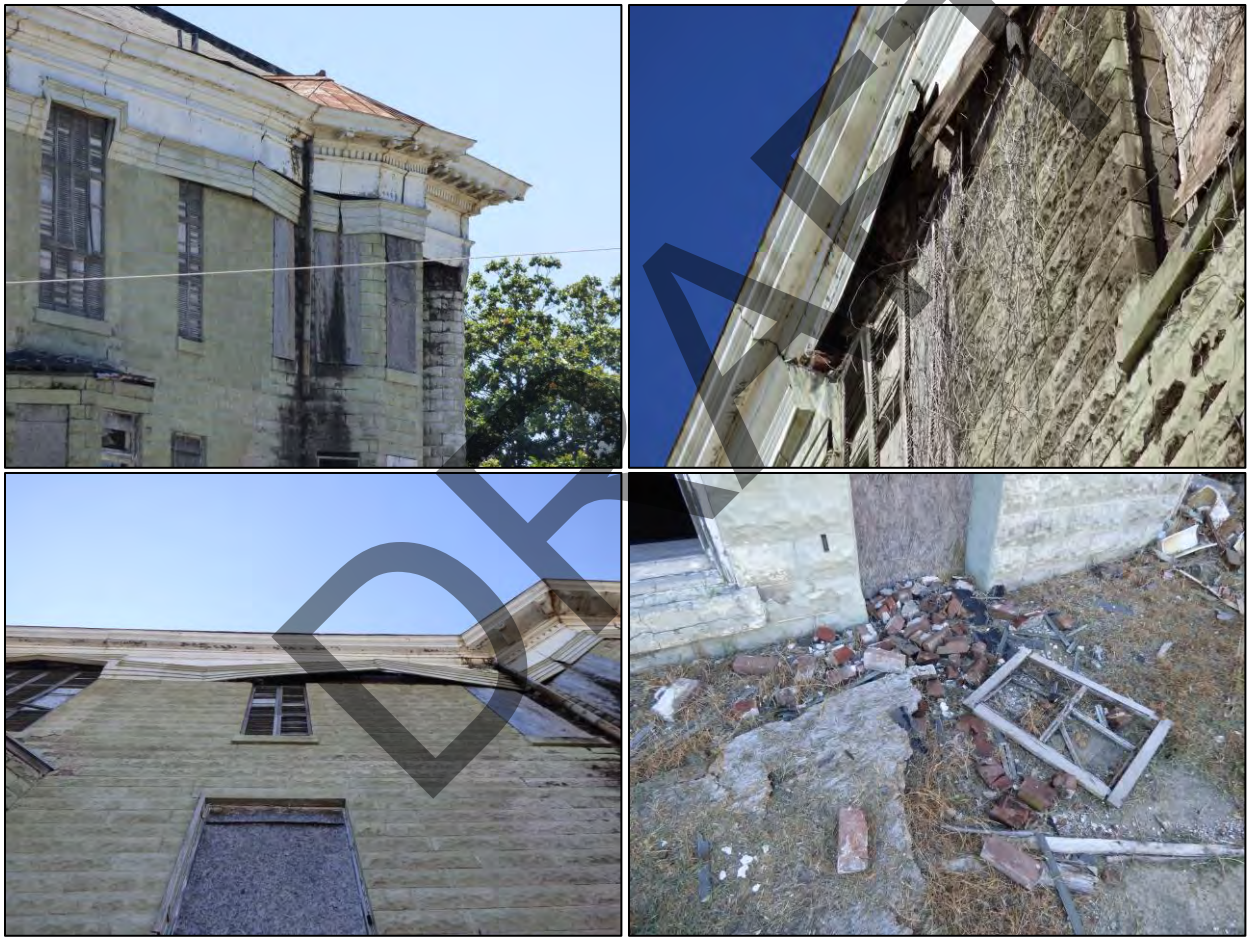
Figures 6 – 9

Figures 6 – 8: Examples of outward frieze movement due to upper brick wall sections collapsing and falling out. Figure 9: Small pile of bricks that fell out from upper wall section.

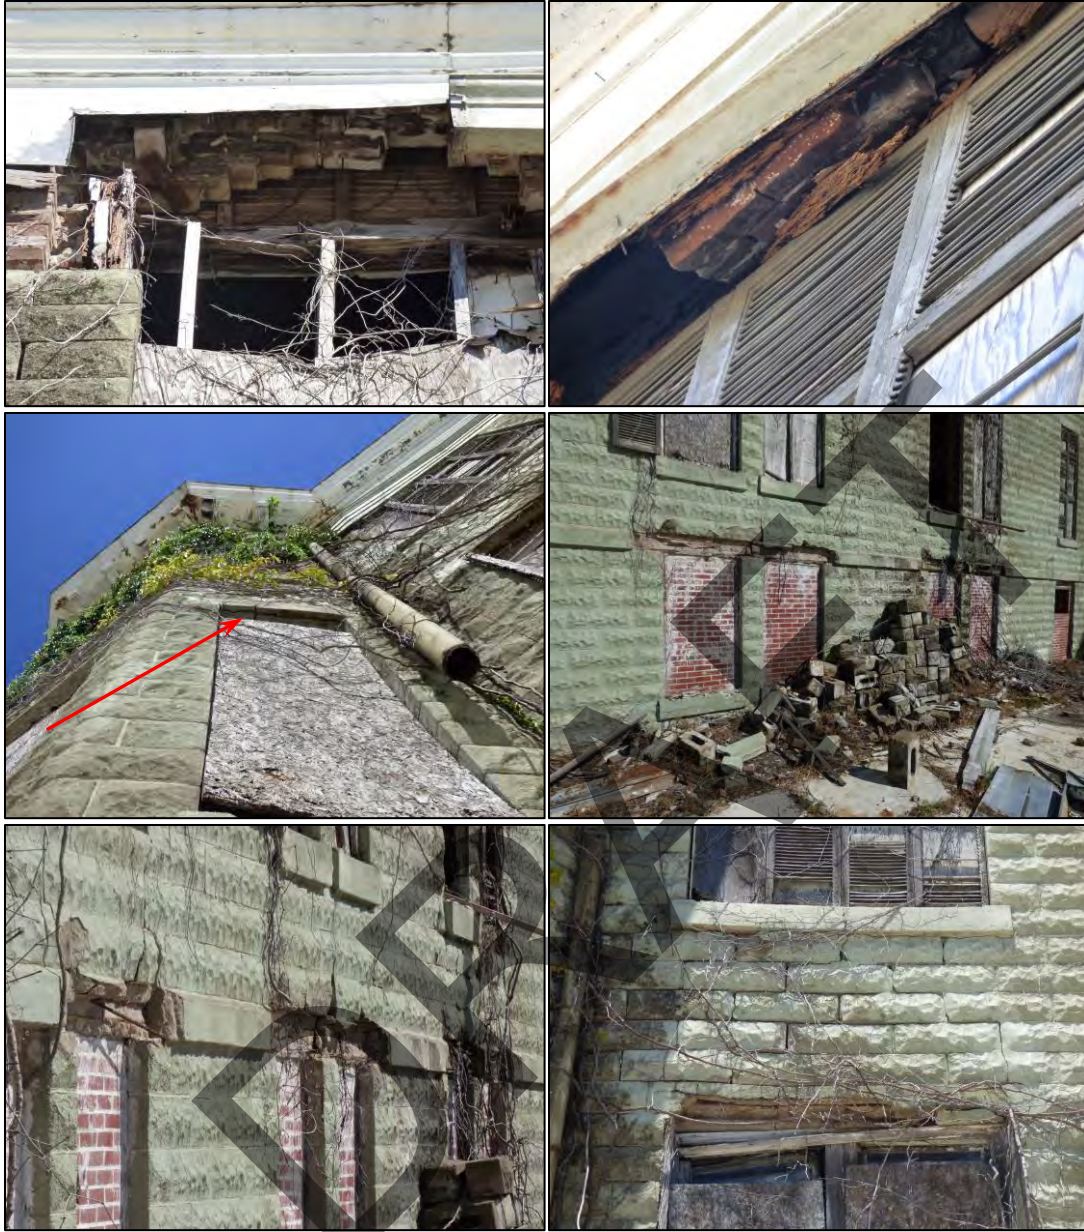
Figures 10 – 15

Figures 10 and 11: Typical examples of upper brick wall sections collapsing and falling out. Figure 12: Broken bond beams along second floor level. Figures 13 – 15: Bond beam failure with exposed concrete infill and deteriorated rebar. Note also the ongoing “arch failure” in figure 15 between the two sets of windows as exhibited by the diagonal separation cracks and the visible deflection.

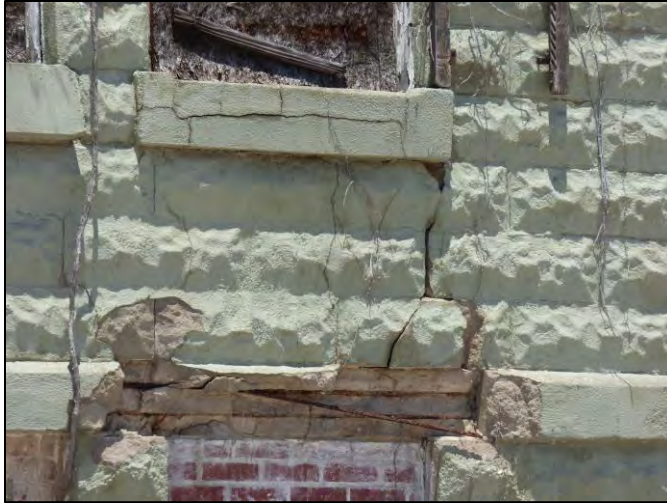
Figure 16

Additional examples of broken header support beams and wall movement.

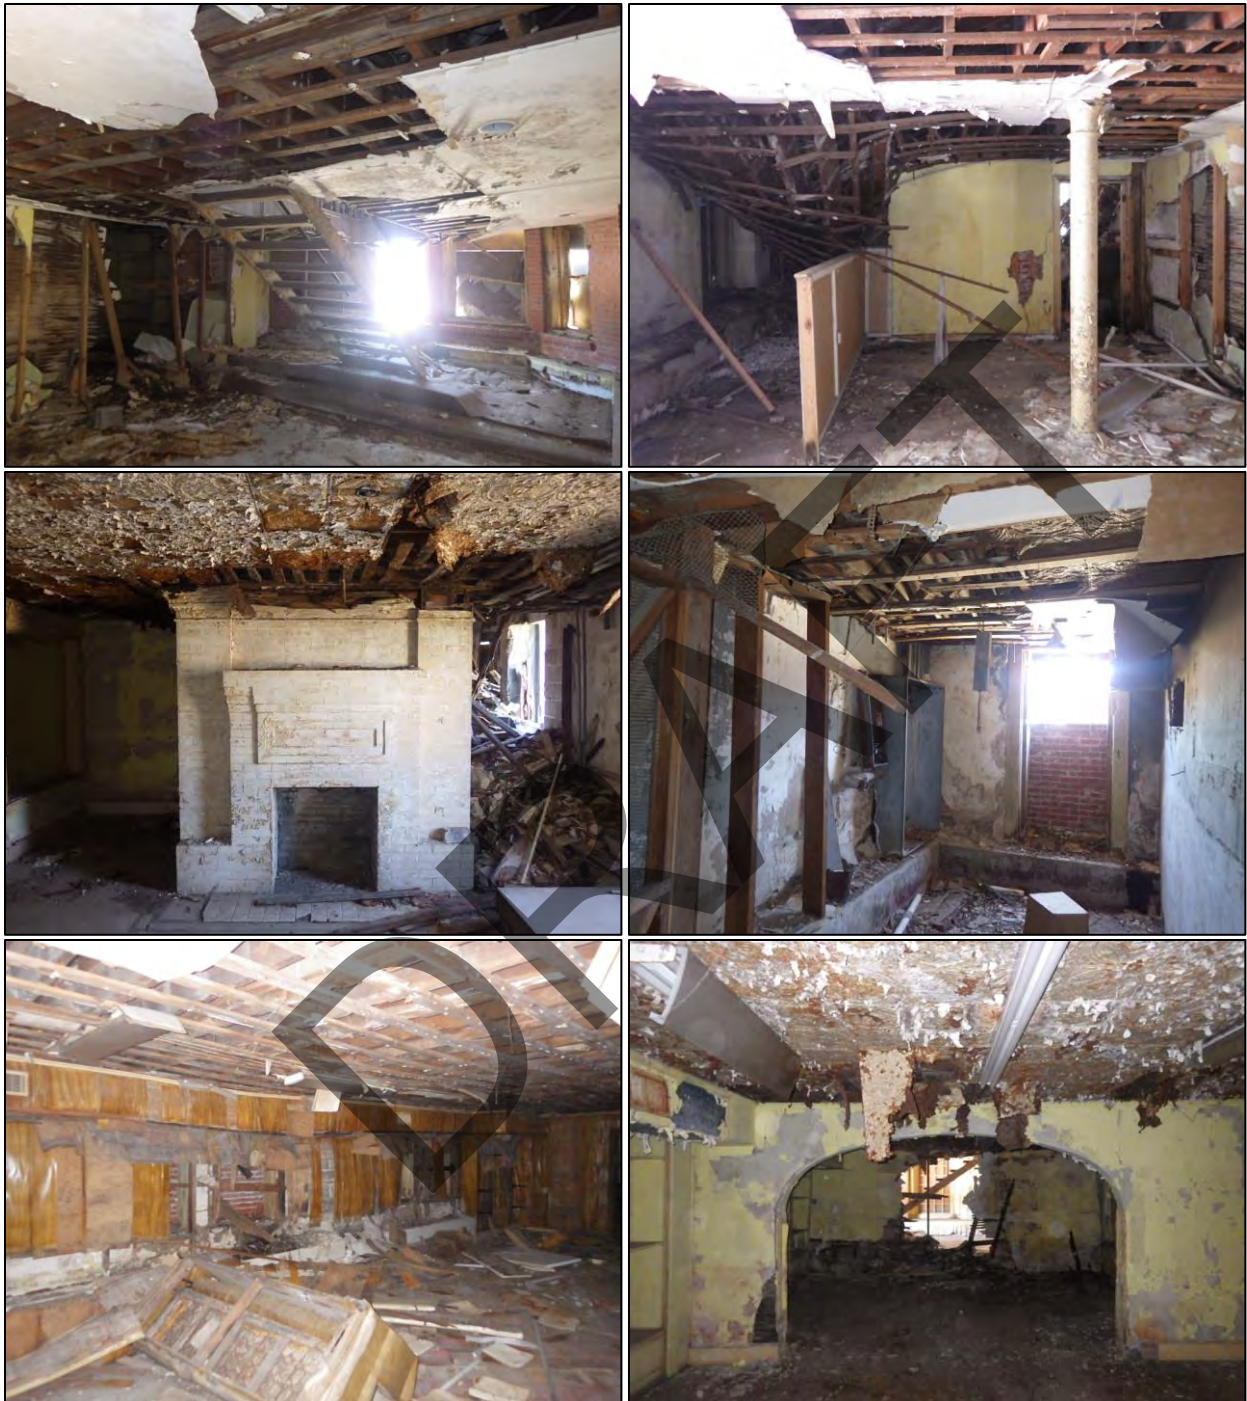
Figures 18 – 23

Typical first floor interior conditions.

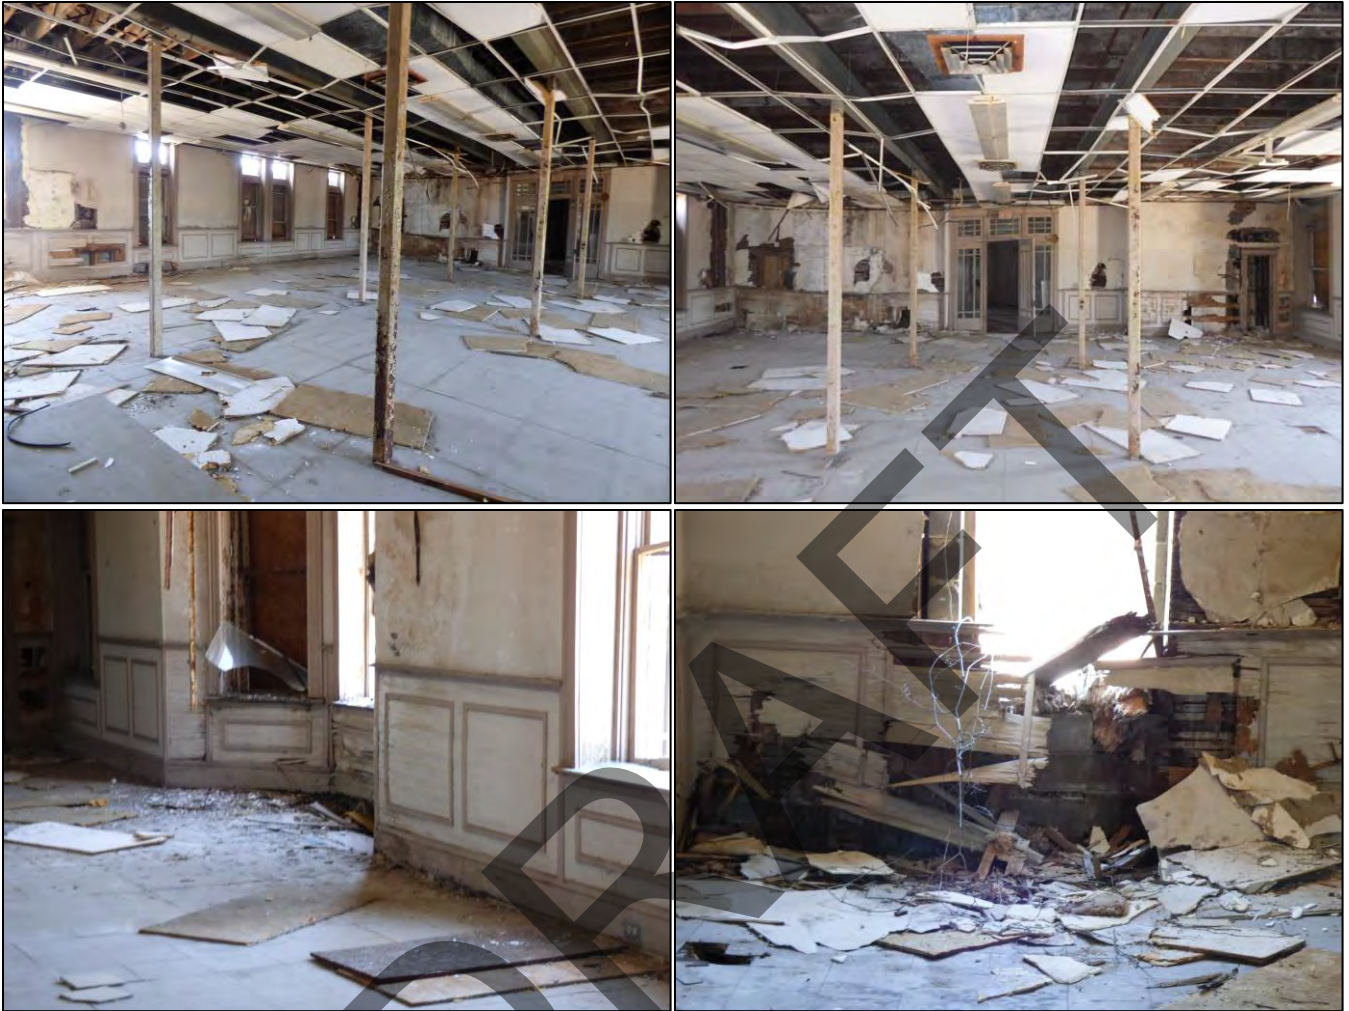
Figures 24 – 27

Figure 24: Open assembly room at second floor looking in a southeastern direction (toward the front from the back). The two rows of square tube steel columns are not original. Figure 25: Same room, looking due southward. Note the partial collapse of the interior wall and door frame. Figures 26 and 27: Examples of heavy deterioration to wall and floor areas with partial collapse conditions of floors.

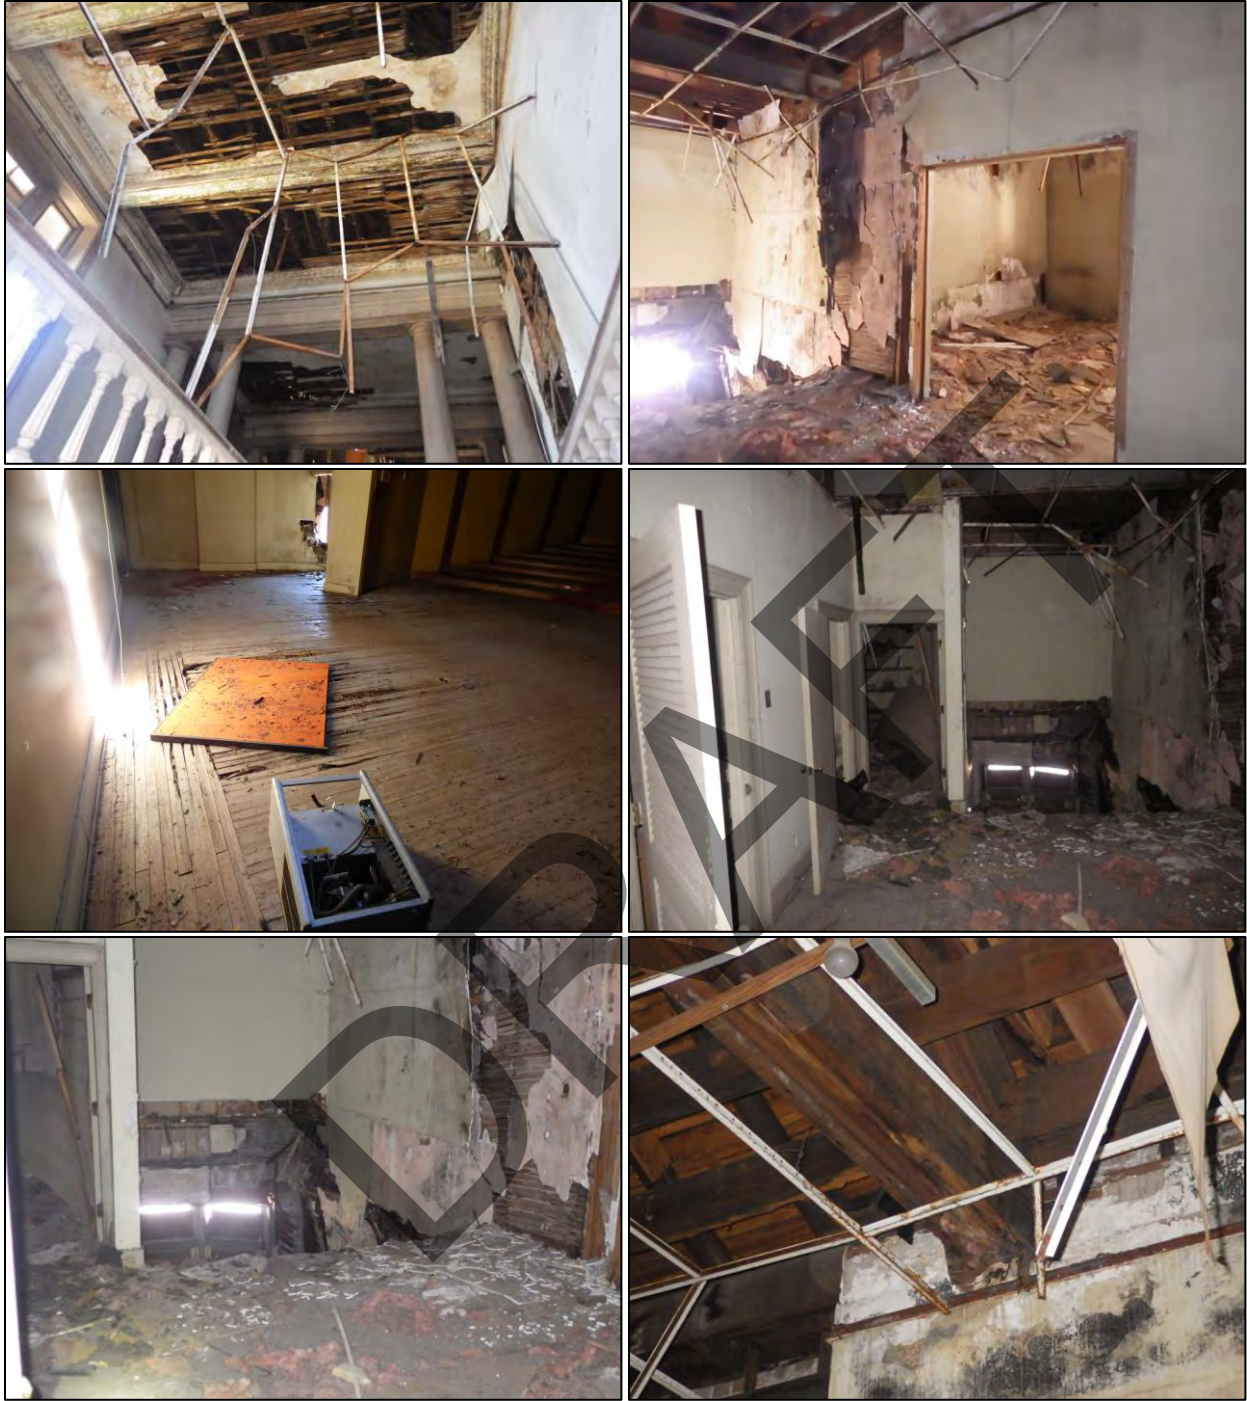
Figures 28 – 33

Figure 28: Underside of third floor framing as seen from the front (south) lobby entry.
